# ARREST/INVESTIGATION REPORT

DATE OF INCIDENT / OCCURRANCE 11/14/2013	TIME (2400) 0900	CITY/COUNTY/JUDICIAL DISTRICT Philo/Mendocino/Mendocino County Superior Court
X" APPLICABLE [X] Narrative      [ ] Arrest Report [ ] Supplemental      [X] Formal Complaint		TYPE OF REPORT ("X" APPLICABLE) [ ] Commercial Fishing      [ ] Hunting      [X] Inland Pollution      [ ] Incident Report [ ] Recreational Fishing      [ ] Trapping      [ ] Marine Pollution      [X] Other
Location/Subject/Incident Name Indian Creek Tributary/Water Diversion-Dam/Brian Padilla		Arresting/Case Officer <b>M.White #808</b>
		Citation Number AD2078015

On 09/10/13 I received a call from Albert E. Prather about a tributary to Indian Creek on his property that was dried up and a suspected water diversion that was related to it. On 09/11/13 I was on uniformed patrol when I met with Prather at approximately 1600 hours. Prather and I briefly discussed the water diversion issue and then he proceeded to show me the diversion. Prather pointed out to me the location on Indian Creek Road in Philo where the tributary flows through a culvert under Indian Creek Road. The tributary was completely dry, and Prather noted to me

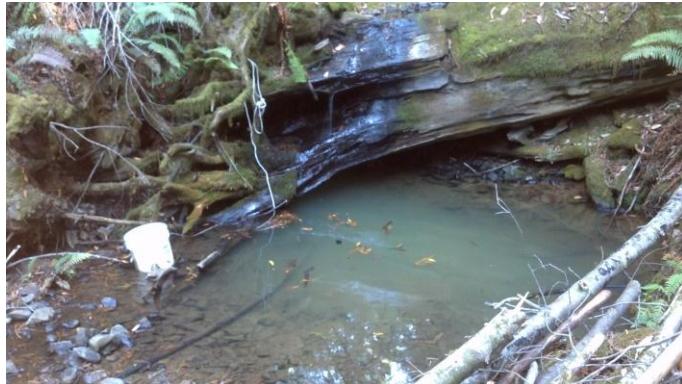
Photo 1

The end of the pipeline was placed in the deepest portion of the pool of water, and the screen on the end of the pipe was insufficient (see photo.1). The waterline ran approximately a half mile downhill in elevation through the canyon in order to gravity feed the water that was being diverted from the pool into two large water tanks (see photo.3) near the bottom of the canyon. The waterline ran through the bed/channel of the tributary for about the first quarter of a mile, and then started up the side of the channel eventually meeting the first of the two tanks. Following the waterline along the bank of the channel, there was a walking trail that followed the waterline, and much of the waterline was suspended from a wire cable that was attached to several redwood trees, cutting into the trees. You could see that the wire cable had chewed into the base of the trees in some areas, and many of the trees had started to grow around the cable. Prather told me that he believed that this water diversion was the work of his neighbor Brian Padilla whom lives at 17601 Indian Creek Road. Prather advised me that Padilla cultivates marijuana, so I advised Prather that I would return to follow where the waterline went after leaving the water tanks on another date with another Warden if possible due to safety, as many of these water lines end up leading into marijuana grows.

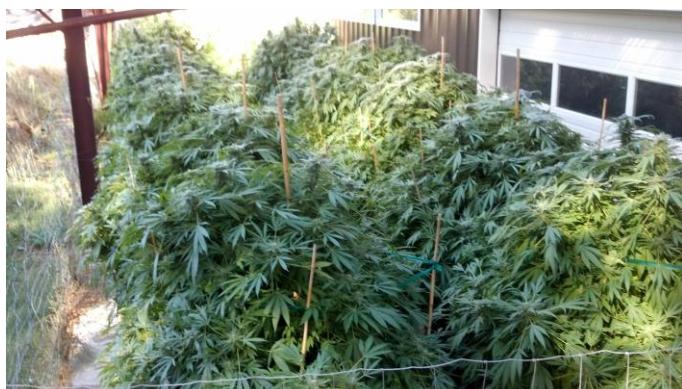
Photo 6

Along with seeing the waterline go to 17601 Indian Creek Road, I also observed approximately 25 large marijuana plants along the north side of the large building structure, several water tanks in the center of the property, and several other small structures on the property (see photo.6). For safety concerns, I advised Stokes that I would come back with another Warden on another day to attempt to make contact with the landowner at 17601 Indian Creek Road.

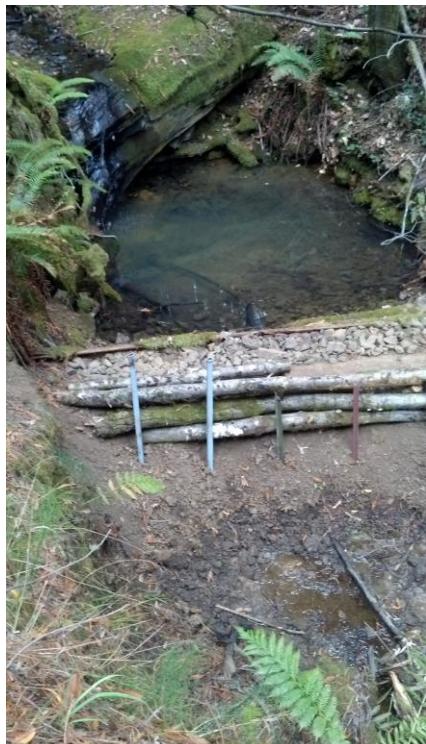
Photo 8  
(Over Head view of Dam)

Prather had been concerned about returning the water back to the tributary, and cleaning out the plastic waterline that was strung throughout his property. Prather was concerned for the safety of his livestock being that his sheep could trip over the plastic piping or ropes that were tied in places along the canyon wall and stumble down to the bottom. Prather asked me if he could remove the water diversion debris that was on his property. I advised Prather that it was his property and it was an illegal diversion, so if he would like to remove it he could. He asked for assistance in restoring the tributary back to original form, so on 11/14/2013 I met Prather on his property at 17501 Indian Creek Road to assist him with restoring the water back to the tributary. Upon arriving at the large pool of water at the main point of diversion, it was apparent that someone had recently built a dam (see photo.8).

The dam had been built out of dirt, rock, and wood debris, with the two inch diameter waterline going through the dam (see attached Environmental Impact Report for dimensions, and negative environmental impact caused by dam). The upstream side of the dam contained a large pool of water, but the downstream side of the dam was essentially completely dried up stream bed. Prather removed the plastic waterline that was in the bed of the creek, going up to the two spring boxes, and up to the two primary water tanks. I attempted to open up the dam to allow passage of water downstream, but

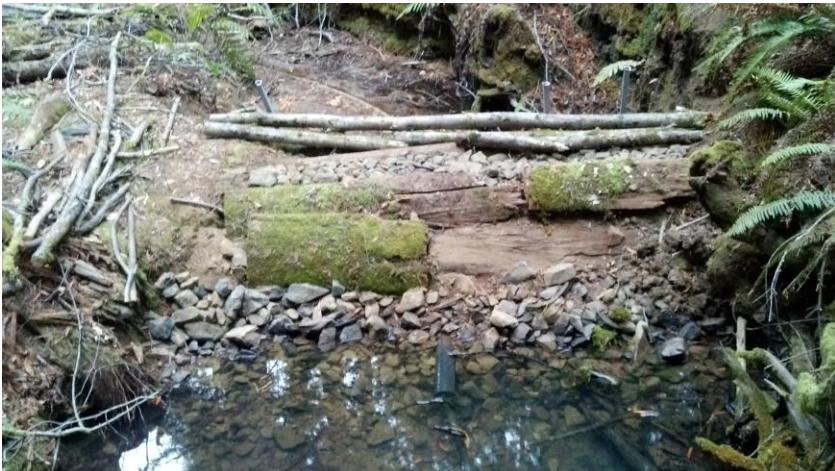
(Looking Downstream at the Dam)

The placement of fill materials creating an on stream dam did not allow for any sufficient amount of water to pass over, around, or by the dam to keep in good condition any fish below the dam (see attached Environmental Impact Report).
